**Flood Control Project Maintenance  
Levee Inspections**  
**LMA District Cover Sheet**  
**Spring 2017 Levee Inspection Results**

**Levee District No. 0001 (Sutter County)**

**Spring 2017 Levee Inspection Results**

Waterway			Bank	Unit Miles
Unit No. 01 Feather River			Right	16.11
	Spring (March - May)	Summer (June - August)	(September - November) Fall	Winter (December - February)
Unit Maintenance Rating (Fall Only)				
Date of Inspection	4/4/2017 - 4/4/2017			
DWR Inspector	Sterling York			
Accompanied By	Andrew Stresser LD0001S

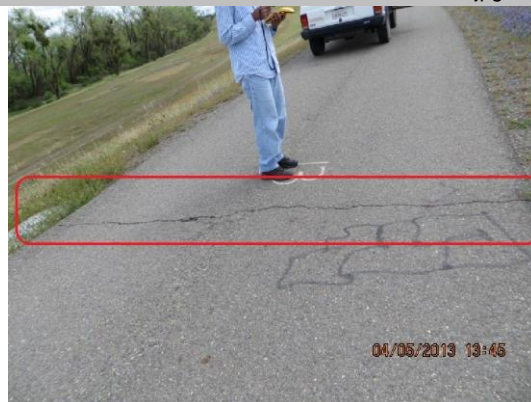
Photo 2 of 3 : UCIP\_SP\_2017\_50675\_19461.jpg

Levee crown overview- siphon breaker on right

LM Start	11.39	Rating **	M	Issue No.	495 (cont)	
LM End	11.39	Issue Type +	En	Location *	LS	
Category	Supplemental			GPS Latitude/Longitude		
				Start		End
Item	DWR UCIP Field Study			39.106261 °		39.106261 °
				-121.607535 °		-121.607535 °
DWR ID						
Comment Code						
Inspector Comment						
FS_ID:50675 DS_ID:18879 EP_NO: N/A Repair Type: Non-Urgent Crossing Status: Not Found UCIP Comments: 07/20/2016 Pipe and pump station removed as part of the Feather River West Levee Project. (K. Fazel - UCIP)04/05/2013 Road pavement cracked along pipe line, needs more investigation. (P. Amatya - DWR) FIELD_STRUCT_DESC: *REMOVED* 2 of 2. A 16-inch pipe (of 6-inch and 16-inch-pipes) through levee, 6.0 feet below crown. Flap gates on waterward end. Siphon breakers in corrugated metal pipe risers on waterward shoulder. Pump house at landward toe. FS Date: 7/20/2016
